# Star Charge Firmware Release Note - E365\_Aries V2\_V2.2703.0 User Unit (Standard)

User Unit: Aries V2 User Unit

User Unit : V2.2703.0\_20251112

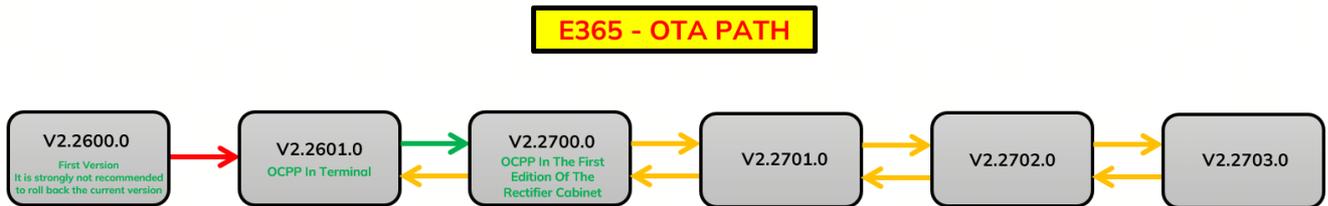
## 3.2 Upgrade roadmap:

Versions prior to 2.2702.0 cannot be OTA upgraded to 2.2702.0 or later versions. Versions 2.2702.0 and later can be upgraded or downgraded normally (2.2701.0 does not support OTA upgrade either).

Due to the abnormal configuration file issue in version V2.2702.0, it is recommended to abandon it directly and not use in the future. The latest update, version V2.2703.0 requires a full card upgrade.
